Analysis of the failure of a PPS polymer cycling support: Microscopy and Finite Element studies

J. Marsh, R.P. Turner*, M. Wang and M.J. Jenkins

School of Metallurgy & Materials, University of Birmingham, Edgbaston, Birmingham, United Kingdom B15 2TT

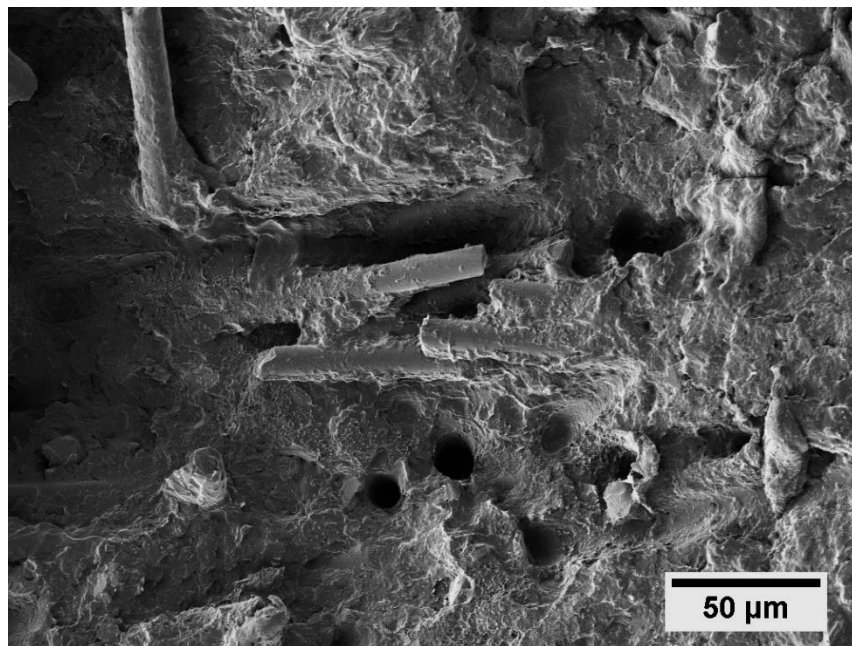
Figure 4: SEM image at the fracture surface of the component at 500x magnification

An important aspect of composites created from a polymer and fibre is the adhesion between the fibre and the matrix. Poor adhesion can result in small micro-voids forming, and this may result in stress concentration sites between the two materials. **Figure 4** shows an SEM image of the fracture surface where the fibres show reasonable embedding in the matrix, with no obvious visible voids between the fibres and the matrix. The light grey cylinders represent the glass fibres, of an average length of $\sim 50\text{ }\mu\text{m}$, within the dark grey PPS polymer matrix. Some evidence of fibre pull-out from the matrix is also observed – these being the two exposed holes in the matrix where fibres used to be embedded.

However, under mechanical loading such as the in-service conditions of this component with the forces applied by the cyclist, the distribution of the loading across the fibres and the matrix needs to be considered, which in turn depends upon fibre orientation [16] The fact that this component is produced with short fibres allows it to be isotropically strong. This would suggest that during normal service loads below the material yield strength, the reinforced polymer would allow for a rebalance of the forces transmitted via the fibres and the matrix in proportion with the strength of the separate phases such that the imparted strain is constant across the two, thus the two phases of the composite remain fully aligned, with no delamination.

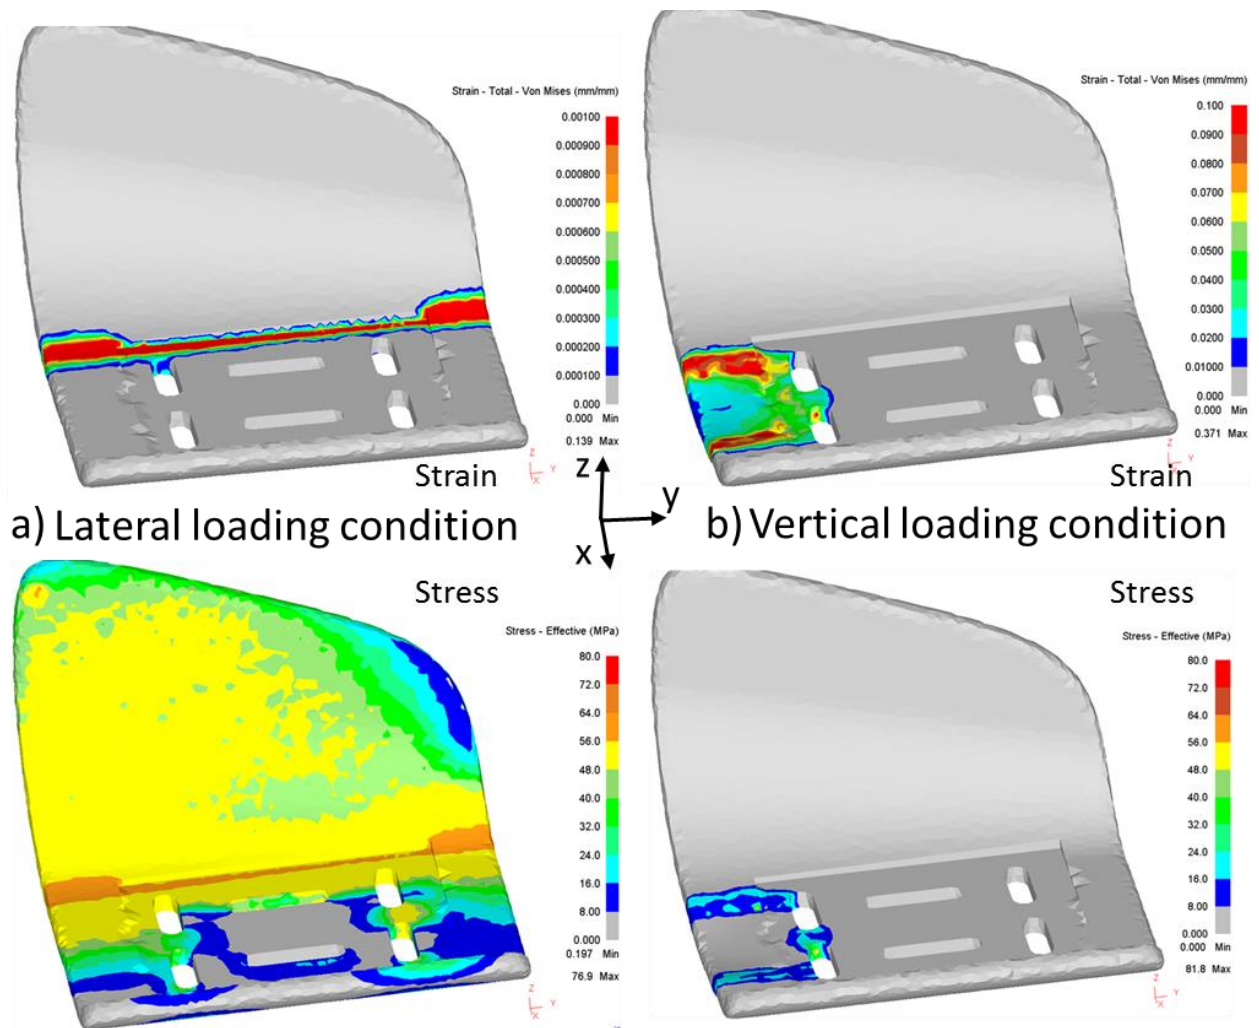
The FE modelling framework to simulate in-service loadings upon the component for the two loading scenarios considered were performed in FE software Deform v11.1. The outputted predictions for the total strain and the effective (von Mises) stress are presented in **Figure 7**. It can be observed from the predicted strain and stress fields (see **Figure 7a**) that for the lateral loading condition the highest regions of effective (von Mises) stresses and effective strains accumulate along the sharp radius of the recessed flat base section of the component. The von Mises stress values are peaking at approximately 60-70MPa according to FE predictions, which is not of concern given the strength of the material in different loading scenarios ranges from 145-180MPa.

Figure 7: FE predictions for plastic strain and Effective stress fields under the two loading conditions

It is hypothesised that at the moment of failure the component experienced abnormal loading, potentially caused by an uneven road surface which may have induced a mechanical shock in to the system. Mechanical shock is a sudden acceleration caused by impact of an object external to the system [17]. Thus, the forces experienced by the component at the instance of fracture may not simply be produced by the mass of the rider under gravitational acceleration, but now are the summation of this internal system force and the external (mechanical shock) force applied due to the acceleration. The more sudden the shock is, so the acceleration increases and thus so does the force upon the component. It has been demonstrated in the literature that even relatively small impact can produce considerable shock when the time-frame is short [17-18]. The inclusion of mechanical shock will likely have a dual purpose upon the component system, firstly the rider in this situation is highly likely to push out their arms further than usual, exacerbating the lateral loading upon the component. Secondly, the summation of the forces acting upon the component at the critical regions along the sharp corner and in-between the affixing holes will now potentially exceed the loading applied by the rider alone.

However, this will force the component to flex along this corner placing one surface in to tension and the other in to compression, providing a potential driving force for any accumulation of damage and cracking to propagate entirely along the recessed section radius. By comparing to the real component that suffered sudden-onset failure (shown in **Figure 2**), it can be clearly observed that the crack path propagated along much of the sharp-radius corner of the recessed base section where it meets the curved wing. It is therefore highly likely that the driving force to exacerbate the crack propagation came from a lateral force as the cyclist's arm slipped during service.

Whereas, when the component is subjected to the vertical loading condition, a small location of high von Mises stress and strain accumulates in between the two affixing holes within the component closer to the vertical force provided (see Figure 7b) and around the radii of these two affixing holes. The region in-between the affixing holes will likely be subject to crack propagation driving forces associated with regions of high stress, and potentially this just requires an initiation site to provide potential failure. As described previously, characterisation and analysis of the fractured component was carried out using Micro CT. These experiments provide detailed information about the internal structure of the component. The bulk component was observed as a dense solid with no sporadic voids visible confirming complete filling of the mould during manufacture. However, a single void in the component was clearly visible in the Micro CT scan along the surface of the crack (**Figure 8**).

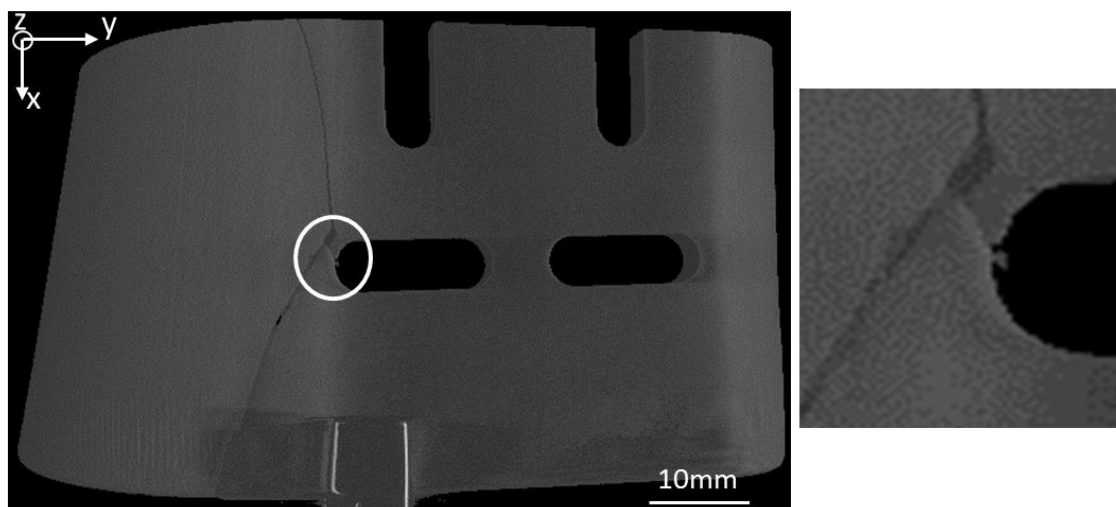
Figure 8: Micro CT image of a void on the crack interface within the component. An additional crack is indicated as another region of interest (circled) and is zoomed in on the right

This void, due to the location of the actual crack surface may be a consequence of either; a) the component fracture and a subsequent loss of material in this location due to damage accumulation, or b) an incomplete moulding process leaving a residual void prior to the component failure. The location of the void - well away from any sharp or small features which may restrict the flow - would likely not suggest an incomplete mould operation and thus the observed void probably a result of the loss of material due to high localised damage at the onset of cracking. However, the direction of the crack from the fixing hole to the void would suggest that a weak point may have been present prior to the sudden-onset failure of the component.

Also observed within **Figure 8** is a crack emanating from the left edge of the left affixing hole, and which joins the main crack which propagated through the component. This crack observed with Micro CT methods is noted to match a location of increased stress and strain from the FE predictions for the vertical loading arrangement. Although the highest region of stress and strain was on the other side of the affixing hole, in the region of material between the two, the presence of the through thickness main crack may have changed stress fields in the component, if we assume this is a subsequent crack. Alternatively, this small crack leading from the affixing hole to the main crack may be another potential nucleation site for the sudden failure, although this seems more unlikely.

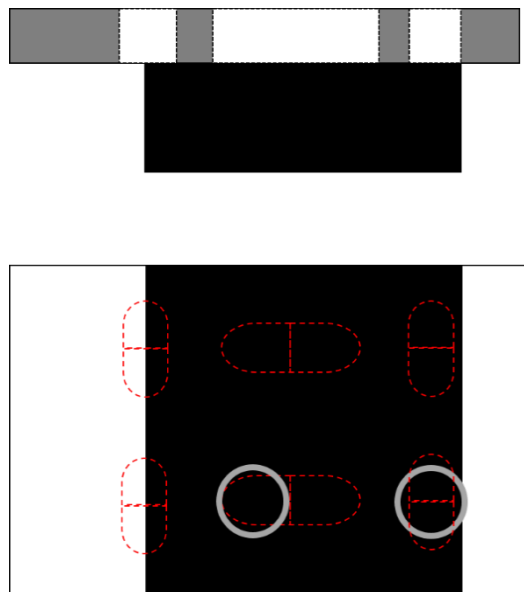
Finally, the location of the arm rest upon the customer-mounted supporting aerobar was believed to influence the failure of the component in this instance. The location of the supporting bar can be varied to accommodate the riders shape, size and riding preference. Two bolts are used to secure the arm rest. The user can choose from the available six affixing holes manufactured in to the component. The two affixing holes used to support this fractured component are shown in **Figure 9** (represented by the grey circles) from a choice of the six available (represented by the dotted lozenges). The black rectangle represents the support that was situated between the bar and the arm rest. It can be observed that the unused horizontal pair of affixing holes on the left of the image is situated on the very edge of the supporting bar. In this configuration, it is likely that the overhanging region acts as a lever for the loading to be applied and with the fulcrum across the centre of the fixing holes where there is a reduced amount of material.

Figure 9: The arm rest location mounted on the aerobar support.
